# Manhole Inspection Summary

Manhole # S09EE2023MH

Record Plat: **09EE2** Node: **023** Status: **Found**

**Location** Address: **5928 GREEN MEADOW PKWY**

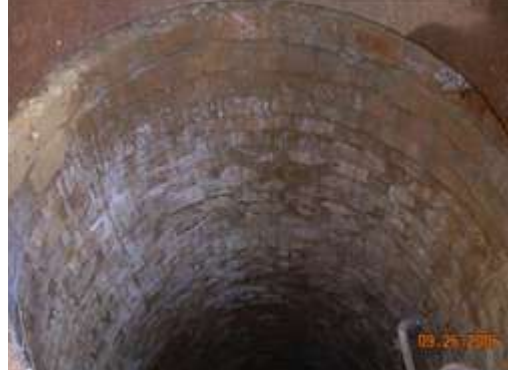
Defect

Infiltration: ☐ None ☒ **Joint** ☐ Cracks ☒ **Mortar** ☐ Roots ☐ Wall

Infiltration: ☐ None ☐ Joint ☐ Cracks ☒ **Mortar** ☐ Roots ☐ Wall

Chimney and Corbel infiltration.

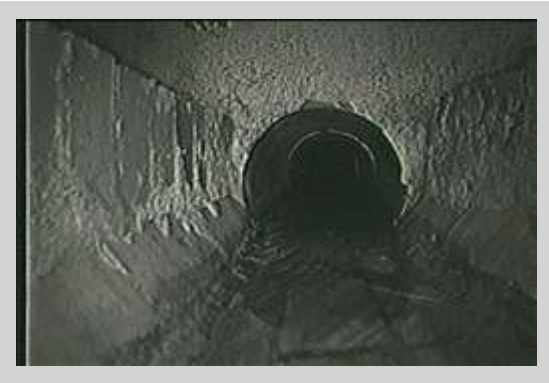
### 8 in. Circular Gravity Sewer Pipe Out @ 12 O'Clock

Pipe Material: **Clay** ☐ Pipe Lined

Invert Depth: **16.71** (ft.) Flow Characteristics: **Slow**

Infiltration: **None** Pipe Seal Cond: **Unknown**

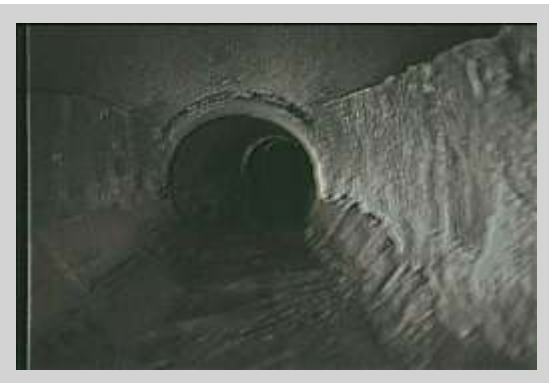
### 8 in. Circular Gravity Sewer Pipe In @ 6 O'Clock

Pipe Material: **Clay** ☐ Pipe Lined

Invert Depth: **16.69** (ft.) Flow Characteristics: **Slow**

Infiltration: **None** Pipe Seal Cond: **Unknown**
